## TECHNICAL BULLETIN

**Bulletin:** CUSTOMER SERVICE\_TECHNICAL\_2025\_07  
**To:** Service Managers  
**cc:** Dealer Principals  
**Subject:** Engine oil level is too high, with DTC P252F:00 (REVISED)  
**Model:** CX-5 Skyactiv-D 2.2DE  
**Issued:** 20/06/2025  
**Category:** Technical

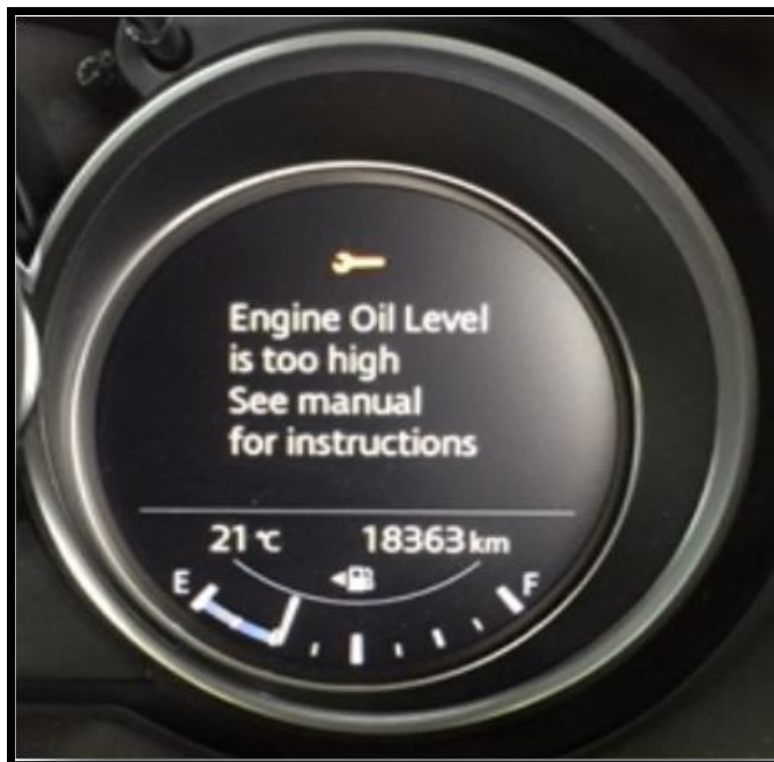
When the oil level is not within the expected operating range, the wrench light illuminates and, in some models, a High Engine Oil Level warning message is also displayed in the Multi-information Display (instrument cluster). This is a maintenance indication only, and in no way determines the vehicle has a technical fault.
